Hogtown Creek

Fact Sheet

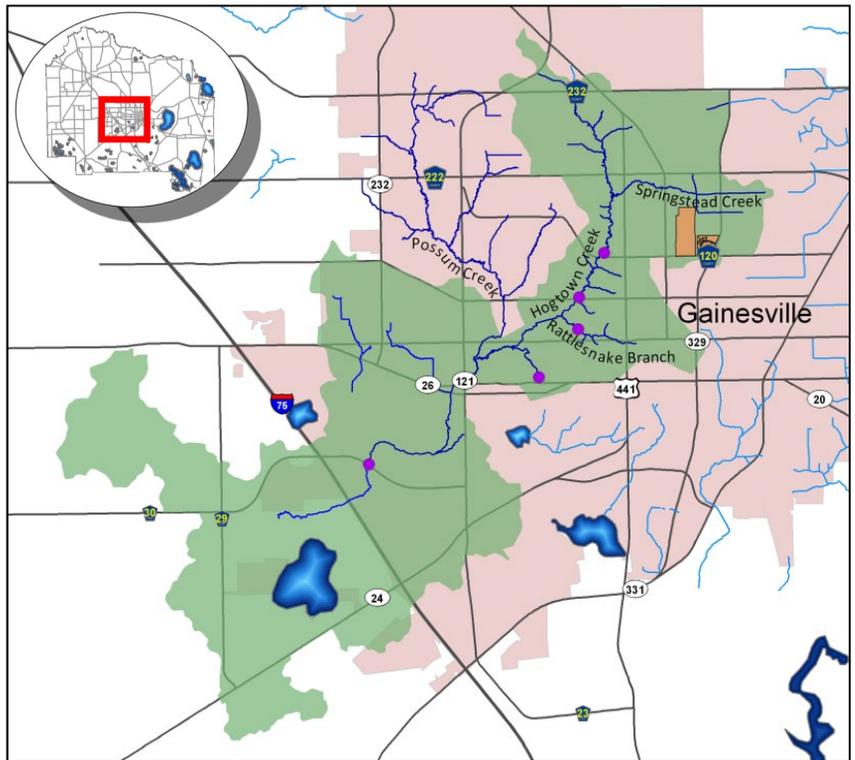
Map of Hogtown Creek watershed (green) with sampling sites (purple circles).

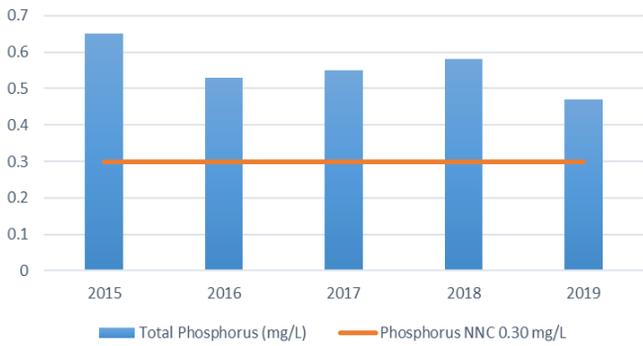
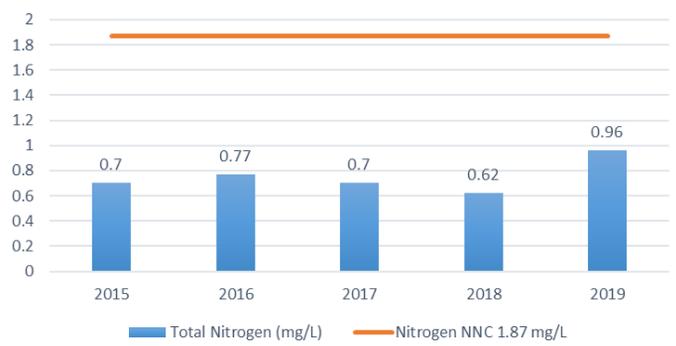
Hogtown Creek Total Phosphorus

Figure 1. Annual geometric mean of A) total phosphorus (TP) and B) total nitrogen (TN) with numeric nutrient criteria (NNC) denoted by orange line.

Nutrients: The FDEP water quality rule on nutrient standards went into effect February 2016. As a result, Hogtown Creek is above the Numeric Nutrient Criteria (NNC) threshold for total phosphorus (TP) but not for total nitrogen (TN). Potential phosphorus sources are the erosion of phosphorus rich soils that compose the Hawthorn clays, which underlay the stream bed. Residential fertilizer inputs could be another source of TP. It does not appear that the elevated TP concentrations are influencing the stream biota.

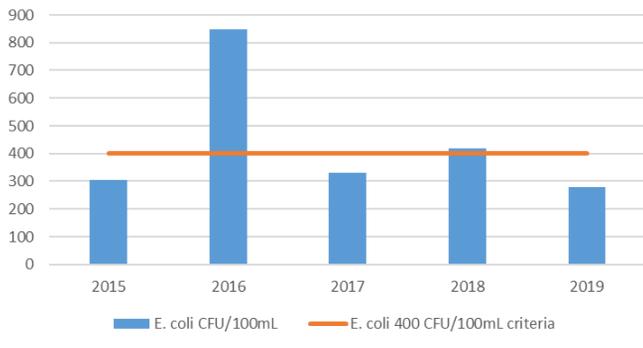
Hogtown Creek *E. coli* Concentration

Figure 2. Annual geometric mean of *E. coli* coliform colony forming units (CFU)/100 mL.

Bacteria: Measuring *Escherichia coli* is the more accurate method of determining fecal contamination of streams. The state standard for a single sample is 400 colony forming units (CFU)/100 mL. Hogtown Creek has been listed as impaired for fecal coliform since it frequently exceeds this standard. Possible sources of this bacteria include urban campers, domestic and wild animal waste, leakage from sanitary sewer lines, faulty private sewer connections and overflows, persistence and regrowth of bacteria in creek sediments, and failing septic systems.
