# Possum Creek Fact Sheet

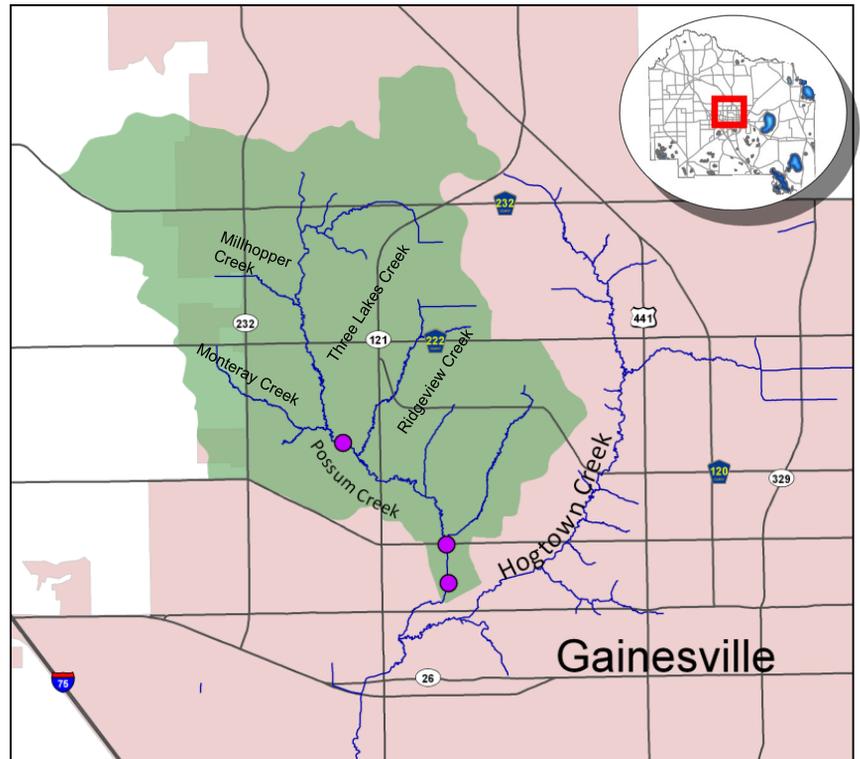
Map of Possum Creek watershed (green) with sampling sites (purple circles).

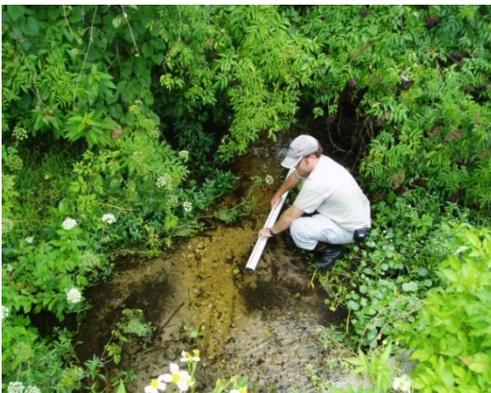
Possum Creek during sampling event.

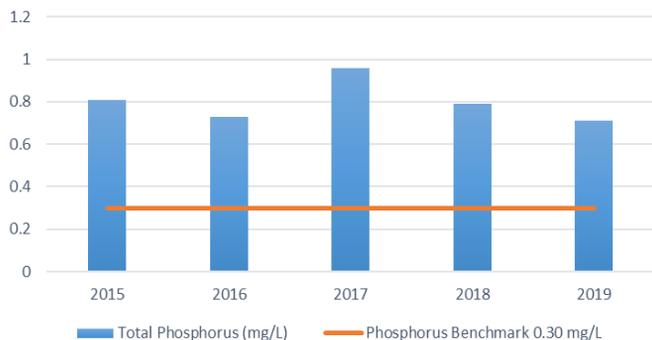
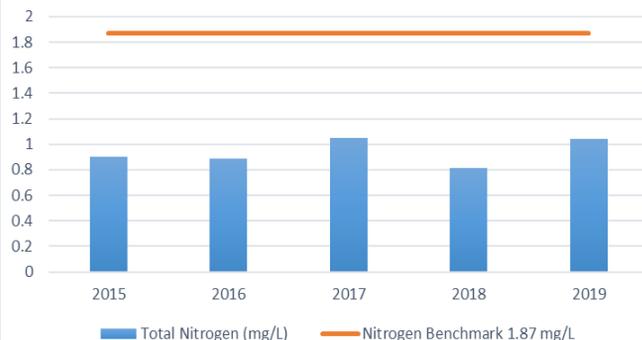
Figure 1. Annual Geometric Mean of A) total phosphorus (TP) and B) total nitrogen (TN).

**Possum Creek Total Phosphorus A**

**Possum Creek Total Nitrogen B**

**Nutrients:** The current FDEP water quality rule on nutrient standards went into effect February 2016. As a result, Possum Creek is above the Numeric Nutrient Criteria (NNC; denoted by orange line on graph) threshold for total phosphorus (TP) but not for total nitrogen (TN). Potential phosphorus sources are the erosion of phosphorus rich soils that compose the Hawthorn clays which underlay the stream bed and residential inputs of fertilizer. It does not appear that the elevated TP concentrations are influencing the stream biota but may be causing dense periphyton that was observed in the Stream Condition Index assessment.

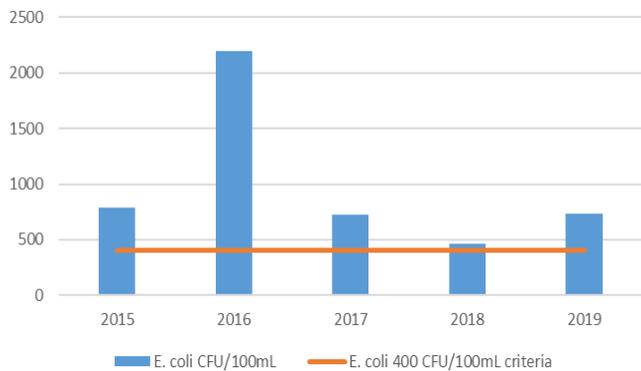
Figure 2. Annual Geometric Mean fecal coliform colony forming units (CFU)/ 100 mL.

**Possum Creek *E. coli* Concentration**

**Bacteria:** Measuring *Escherichia coli* is the more accurate method for determining fecal coliform contamination in streams. The state standard for a single sample is 400 colony forming units (CFU)/100 mL. Possum Creek has frequently exceeded this standard and has been classified as impaired by FDEP. Possible sources of this bacteria include domestic and wild animal waste, leakage from sanitary sewer lines, faulty private sewer connections and overflows, persistence and regrowth of bacteria in creek sediments, and failing septic systems.

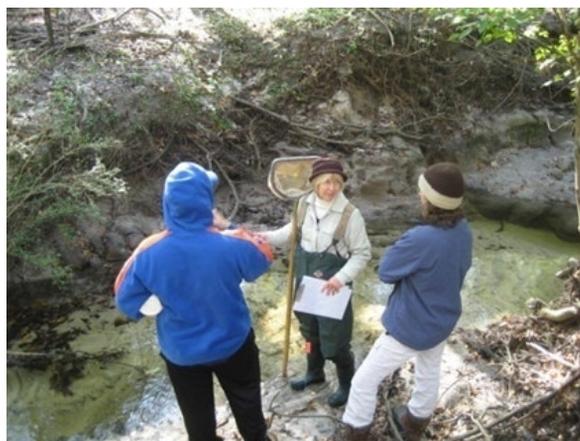
Biological survey of Possum Creek.

Biological surveys of Possum Creek were conducted at two locations on the creek and indicated that the stream had a healthy population of benthic macroinvertebrates with ample habitat. The 2014 survey scored Possum Creek as healthy for Stream Condition Index (SCI). It was noted that in areas with open canopy, there was dense periphyton and aquatic plant growth.
